RTI Errata

MARC4 4-bit Microcontrollers

Errata Sheet

Rev. 4814A-4BMCU-06/04

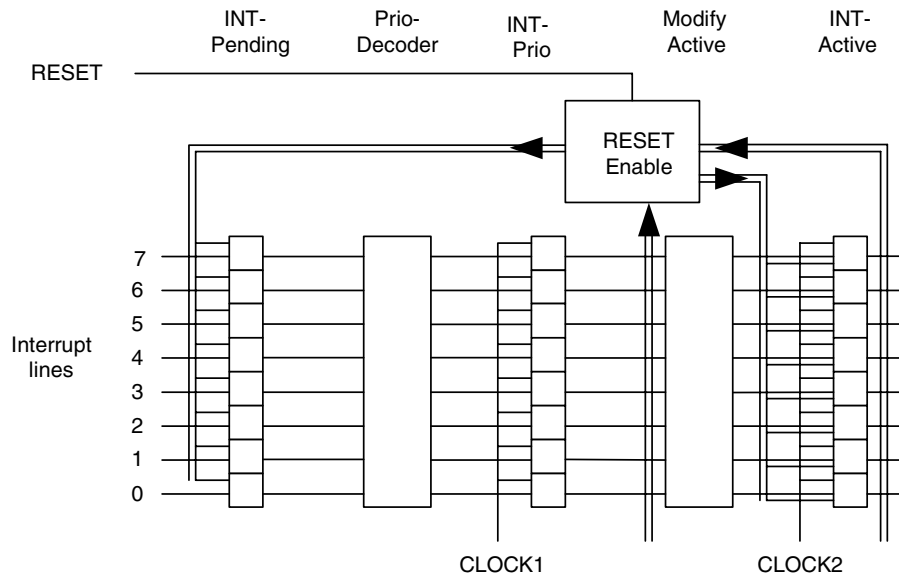
Figure 1. General Structure of the Interrupt Controller

Figure 1 on page 2 shows a simplified block diagram of the MARC4 interrupt controller. It consists of a pending register that keeps all interrupt requests until they have been processed, the priority decoder and the priority register that select the interrupt with the highest priority, and the active register that keeps the interrupts in process until the corresponding RTI has been executed.

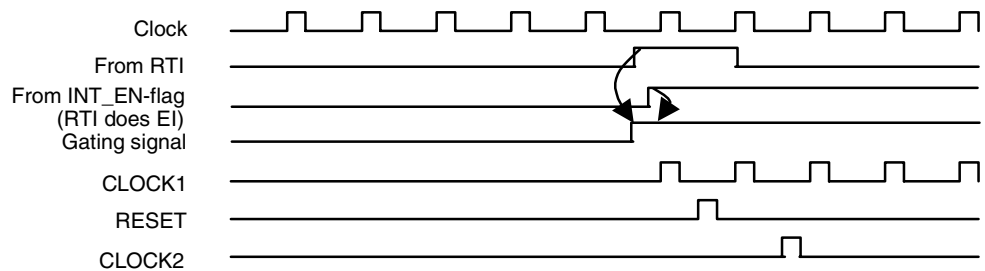
Figure 2. General Timing of the Reset Sequence

During the RTI, the RESET Enable block controls that the RESET only removes the just finished interrupt, i.e., the one with the highest priority, from the pending and the active register. The first CLOCK1 is redundant, the next CLOCK1 signal following the RESET transfers the modified information from the pending to the priority register. If more than 1 interrupt is pending, only the flag for the interrupt with the highest priority is set to “1” in the priority register. CLOCK2 updates the active register. If there is already an interrupt active, it has not been overwritten by the new priority. Only interrupts with a priority higher than the one just active are added to the active register. This allows the controller to return to the previous interrupt service routine when it has finished processing the interrupt with the higher priority.

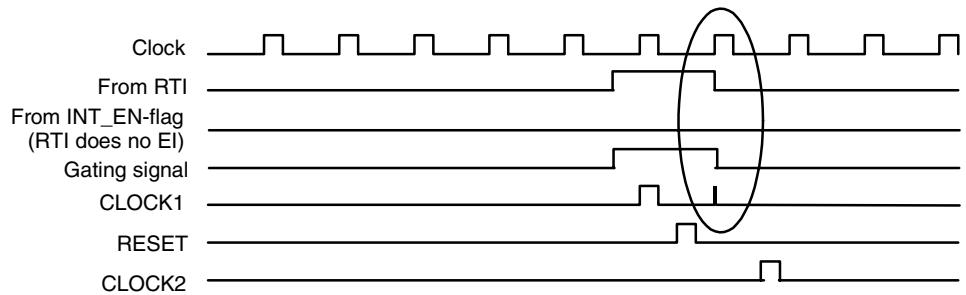
Figure 3. Spike in the Reset Sequence

The root cause is an unforeseen influence of DI, the command following DI and the RTI to the CLOCK1-gating signal. The duration of this decoded signal is shortened if the enable interrupt flag is reset (interrupt disabled). Depending on the command following the DI, the valid and necessary second CLOCK1 is reduced to a spike (NOP) or completely disappears (CALL, LIT_x...).

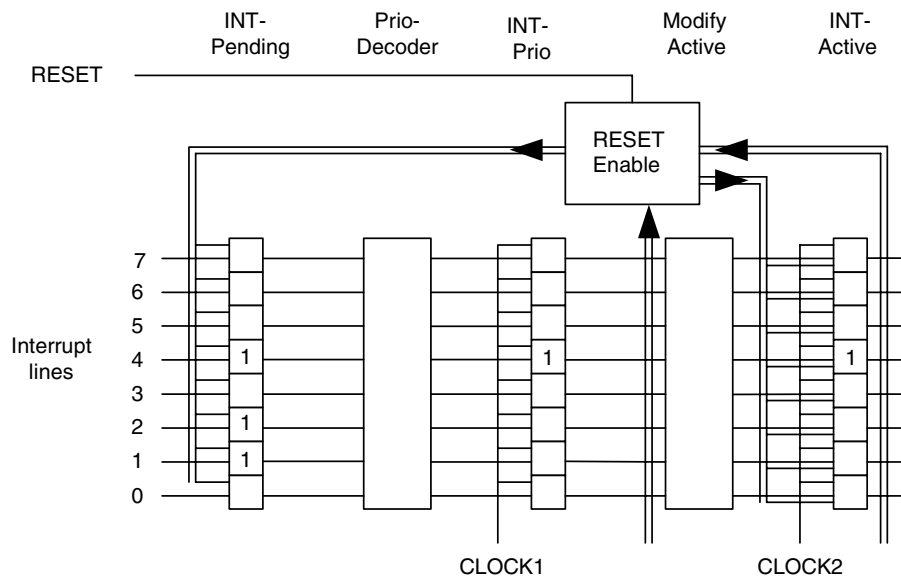
Figure 4. Status Before RTI

The effect of this behavior to the interrupt registers is the following. If an interrupt exactly meets a DI, it is nevertheless stored in the pending register, transferred to the priority register and then to the active register (Figure 4). It stays in the active register as long as the controller does not return from the corresponding interrupt service routine.

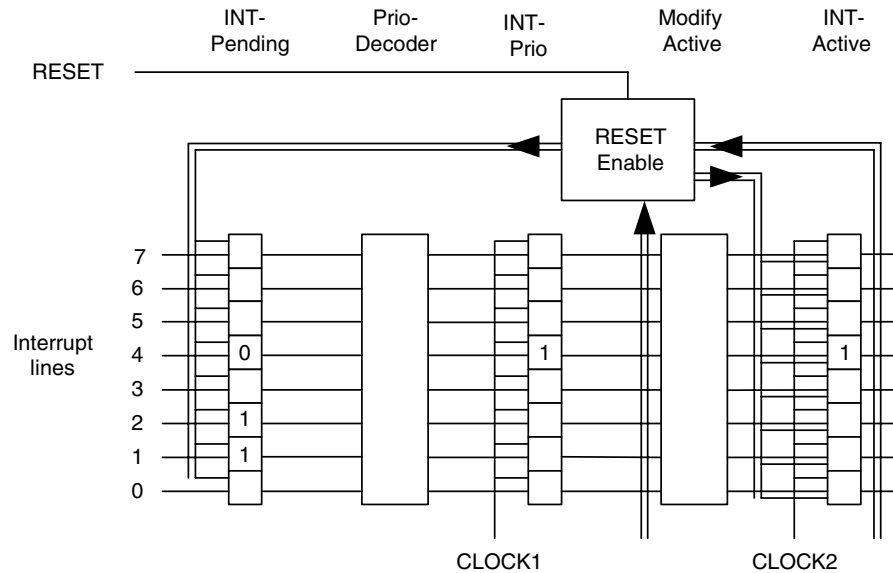
Figure 5. Status After RTI

The above described modified reset sequence starts with the RTI. If the command following the DI is a CALL, the first CLOCK1 does not change anything, the RESET forces the relevant bits from pending and active register to zero, the next CLOCK1 signal is missing and leaves the priority register unchanged, the adjacent CLOCK2 takes over the information from the priority register again (Figure 5). As long as the active register is set, the controller cannot execute a new interrupt of the same or a lower priority.

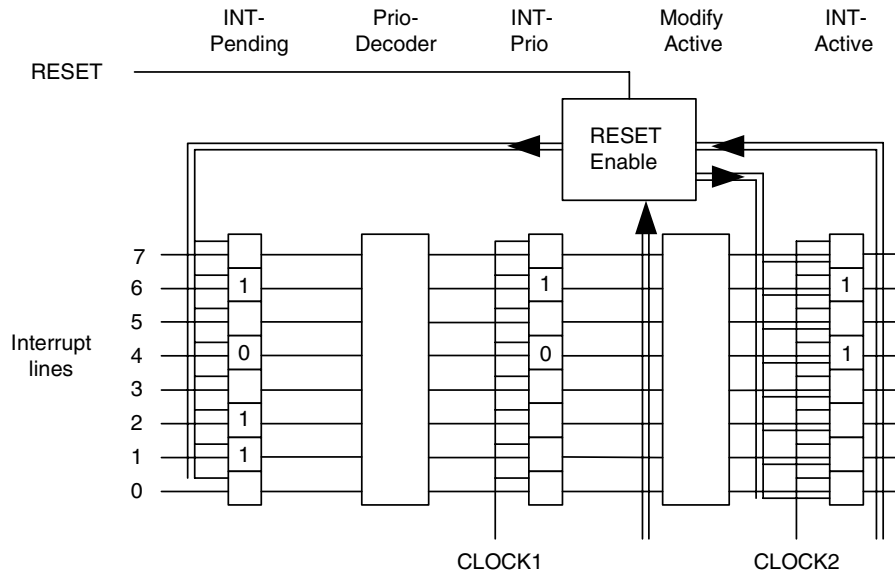
Figure 6. Interrupt with Higher Priority Appears

Even an interrupt with a higher priority, entering the pending register, does not finish this lock-up condition. This event leads to an update of the priority register. Only one interrupt, the one with the highest priority, is stored here. It does not delete the wrong contents from the active register but adds the higher priority interrupt to it. Deleting an interrupt from the active register is only possible if the corresponding bit of the priority register is set.

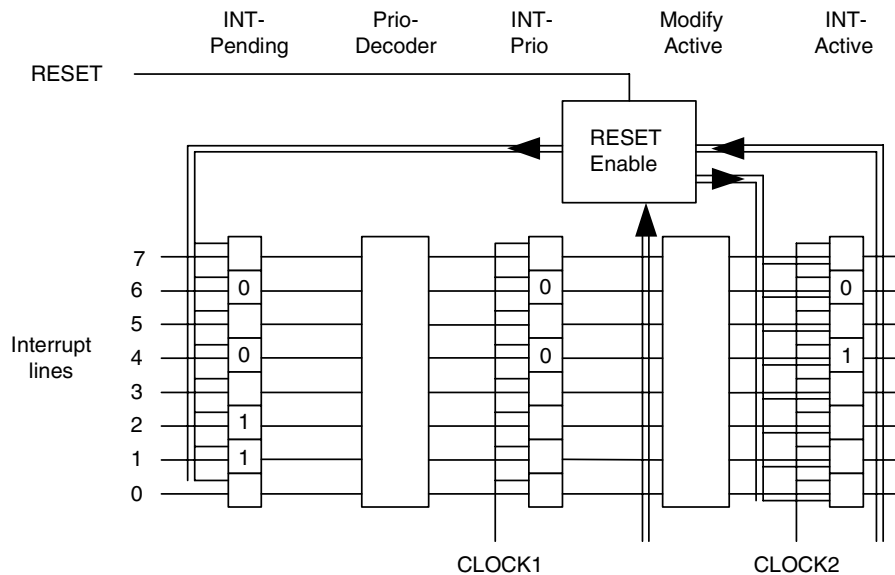
Figure 7. Interrupt with Higher Priority Finished

The RTI resets the bits of the active and the pending register that are marked in the priority register. This new content is evaluated and transferred to the priority register. Then, the higher interrupt will be finished, but the lower one will be still kept in the active register, continuously disabling interrupts of the same or lower priority.

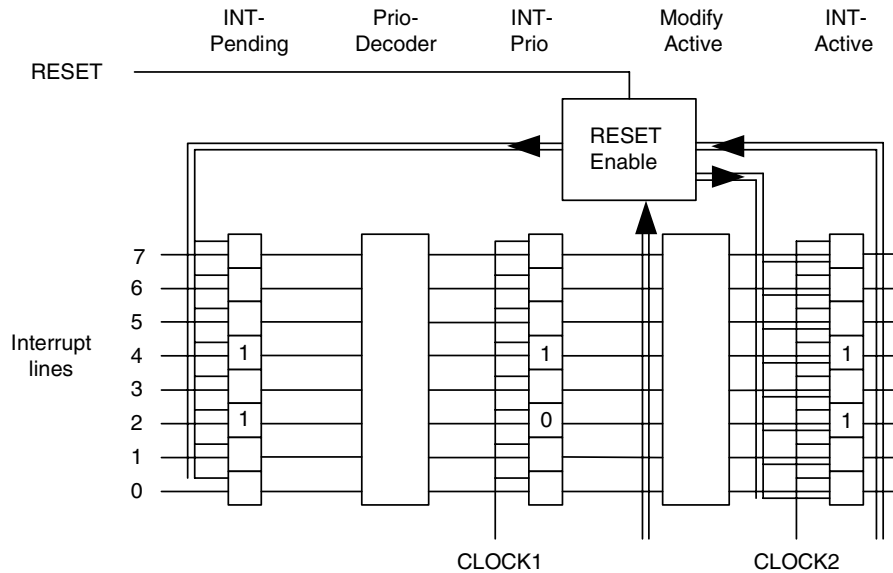
Figure 8. Interrupted Interrupt

The following example describes a special condition: A first interrupt (for example INT2) has entered the pending register normally, is active and the service routine is just under execution. This routine contains a DI command. If a second interrupt (for example INT4) with a higher priority exactly meets this DI, the DI will be executed but the controller jumps to the service routine related to the higher interrupt. The register status at this moment is given in Figure 8.

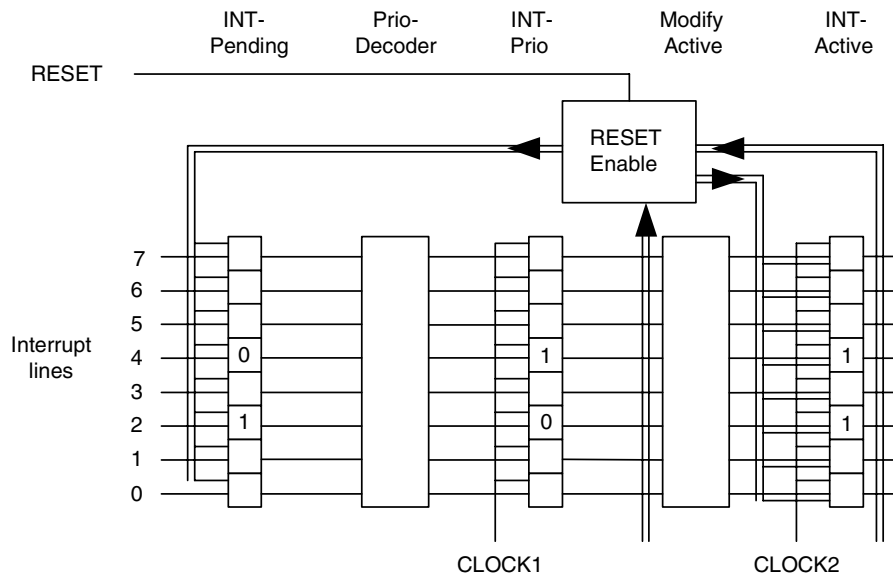
Figure 9. After Return from INT4

Finishing INT4 causes the program control to switch back to the INT2 service routine that was interrupted before. Due to the missing CLOCK1 after RESET, however, the priority and the active register stay unchanged after the reset sequence, while the INT4 flag in the pending register is deleted.

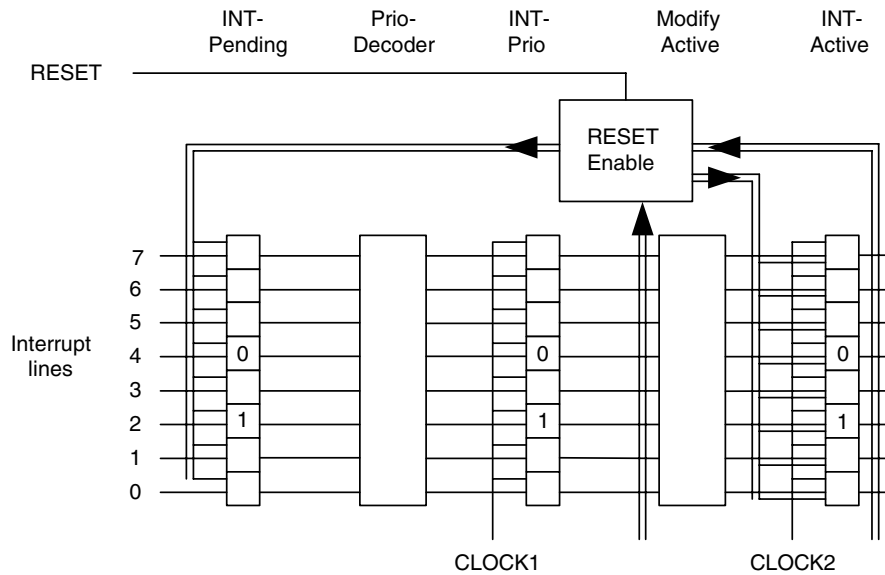
Figure 10. After Return from INT2

Then, the controller continues processing the INT2 service routine. Leaving this routine with the RTI activates once more the reset sequence. The highest interrupt, marked in priority and active register, is deleted from the pending and the active register with RESET. CLOCK1 and CLOCK2 update the priority and the active register as shown in Figure 10.

This time it is not the interrupt that met the DI (INT4), but the one that has already been active before (INT2) that blocks further interrupts of the same or lower priority.

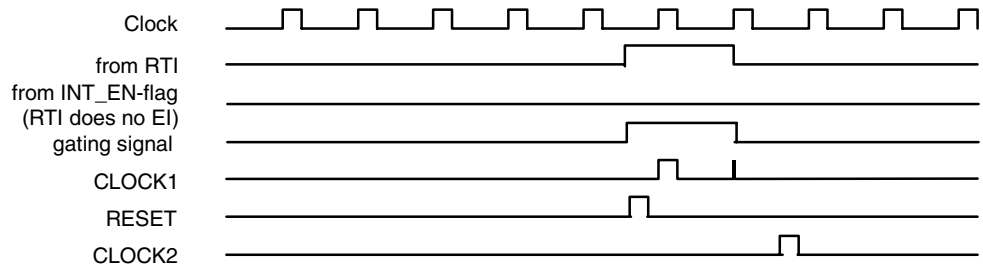
Figure 11. Modified Timing

The described function is caused by an undetected influence to the timing of the interrupt controller's reset sequence. To solve this issue, Atmel will correct the timing. First, the MTP-parts ATAM893 and ATAM894 will incorporate this enhancement. The modification under test conditions is shown in Figure 11.

Moving the RESET in front of the first CLOCK1 solves the issue of the missing second CLOCK1. Now, the reset sequence starts with the RESET of the active and pending register, then CLOCK1 updates the priority register and CLOCK2 updates the active register. To ensure proper operation under all conditions, intensive simulations with different software configurations are ongoing. The hardware revisions of the corrected MTPs will be named ATAM893T and ATAM894R. They will be available in Q3/2004.
