## Introduction

Thank you for your interest in the Xilinx Spartan™-3AN family XC3S50AN FPGA device engineering samples. Although Xilinx has made every effort to ensure the highest possible quality, these devices are subject to the limitations described in this errata notification. These errata do not apply to the XC3S50AN production FPGAs.

## Device Identification

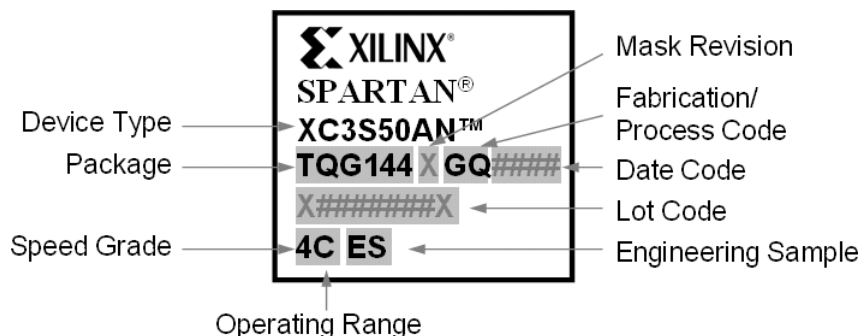
Figure 1: XC3S50AN FPGA Top Marking

These errata apply to the XC3S50AN engineering samples as shown in [Table 1](#). See the top-mark in [Figure 1](#).

XC3S50AN engineering samples are marked as shown in [Figure 1](#). The other devices listed in [Table 1](#) are marked similarly.

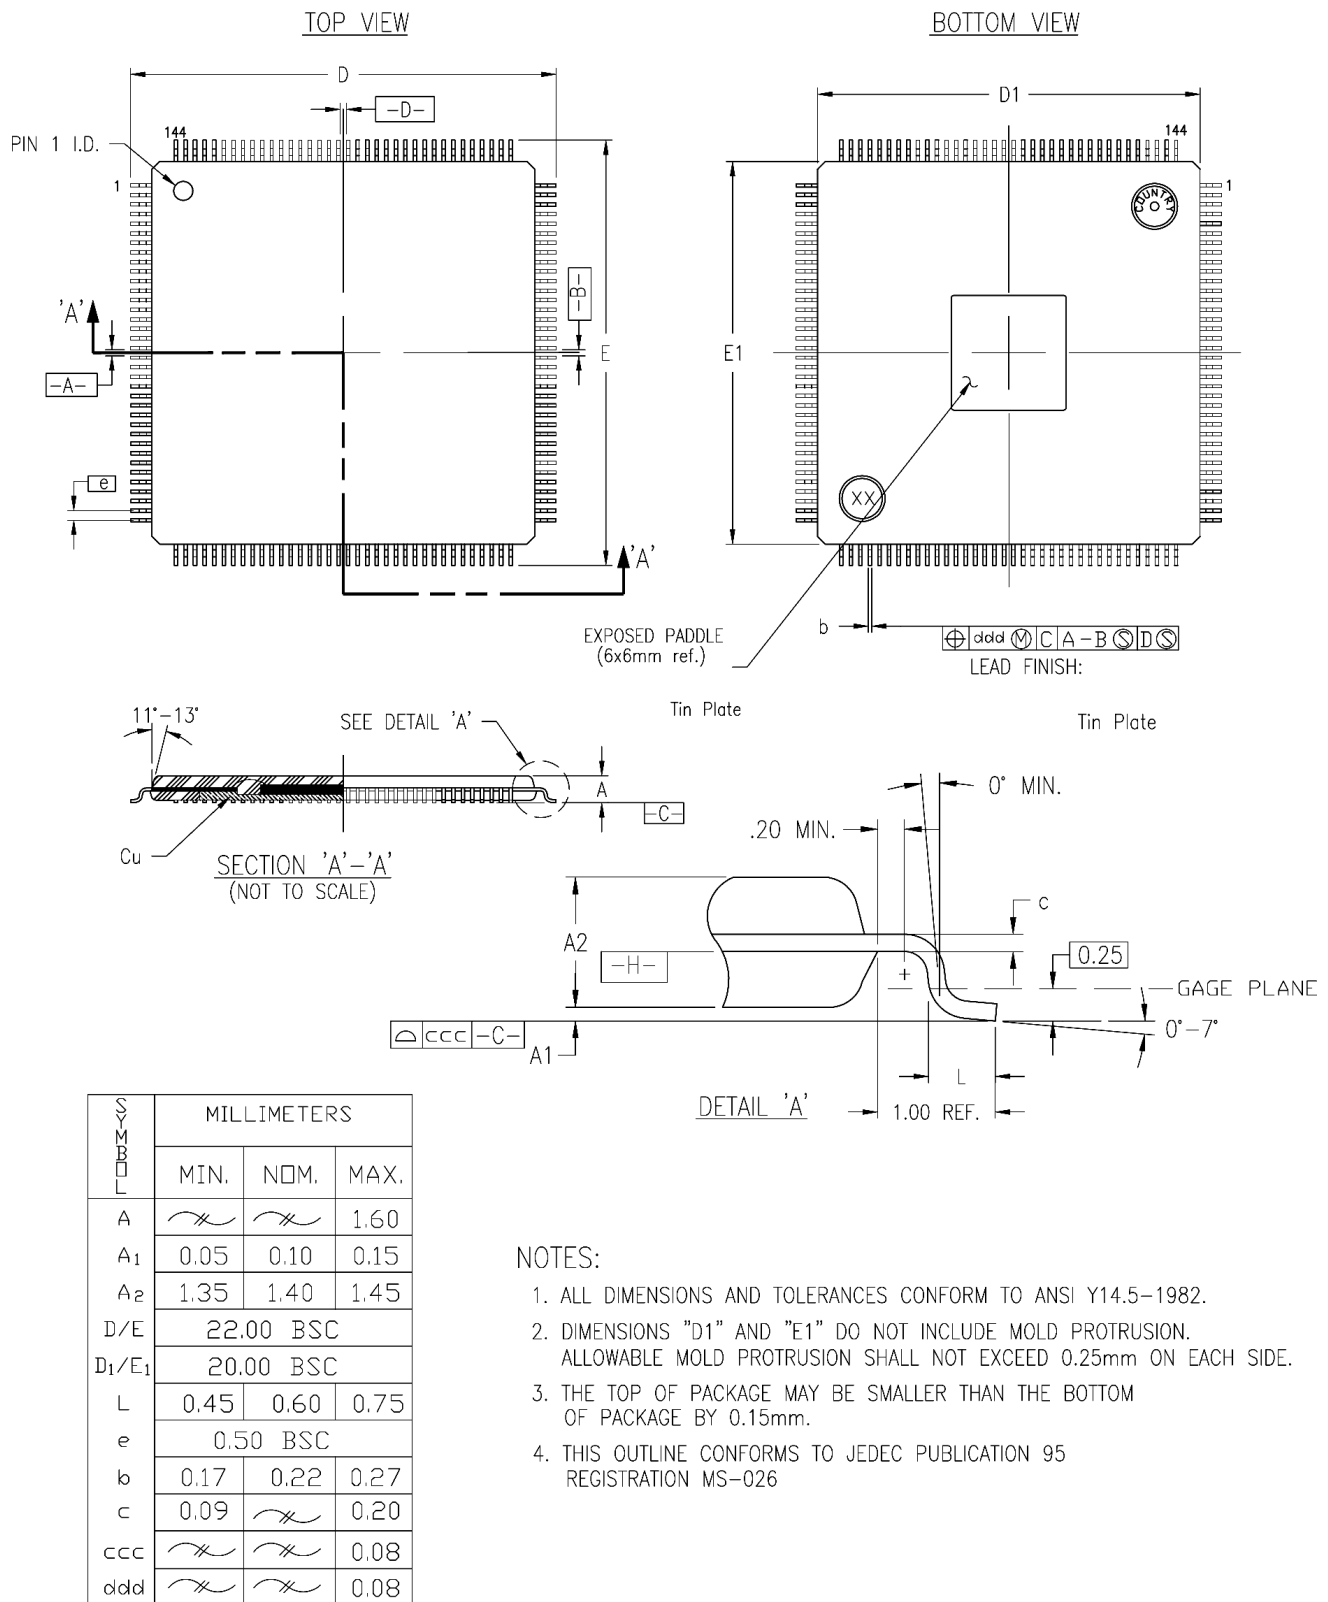
Figure 2: XC3S50AN ES Package Dimensions with Exposed Pad

The XC3S50AN FPGA engineering samples are offered in only one package and therefore this issue could affect all applications. This issue specifically restricts applications that route signals under the package.

The XC3S50AN engineering samples are assembled in a non-standard package with an exposed metal pad on the bottom. The package dimensions shown in [Figure 2](#) match those of the standard TQG144 package which will be used for production. As shown in [Figure 2](#), the package used for the engineering samples has an exposed pad in the middle of the bottom side, with maximum dimensions of 6mm x 6mm. The exposed pad package is typically used to enhance thermal characteristics and signal integrity, but is not being used for those reasons. The package is only a temporary solution until the production package is available. All thermal, material, and reliability characteristics of this package are similar to those of the standard package.

Do not route signals in the area of the exposed pad. The exposed pad can be unconnected on the board, or it can be connected to GND. Do not use the engineering samples for qualification.

This issue has been corrected in production revisions of the XC3S50AN device. Production devices use the standard TQG144 package, with a different assembly process and without the exposed pad.
