Introduction

Thank you for your interest in the Xilinx Spartan™-3AN family XC3S200AN FPGA device engineering samples. Although Xilinx has made every effort to ensure the highest possible quality, these devices are subject to the limitations described in this errata notification. These errata do not apply to the XC3S200AN production FPGAs.

Table 1: XC3S200AN Devices Affected by These Errata

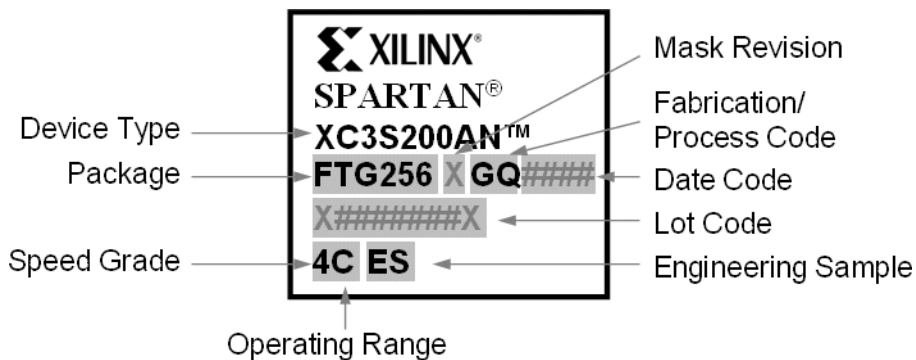
Figure 1: XC3S200AN FPGA Top Marking

XC3S200AN engineering samples are marked as shown in [Figure 1](#). The other devices listed in [Table 1](#) are marked similarly.
