Introduction

Thank you for your interest in the Xilinx Spartan™-3AN family XC3S700AN FPGA device engineering samples. Although Xilinx has made every effort to ensure the highest possible quality, these devices are subject to the limitations described in this errata notification. These errata do not apply to the XC3S700AN production FPGAs.

ICAP Commands including MultiBoot Unavailable after Configuration from In-System Flash

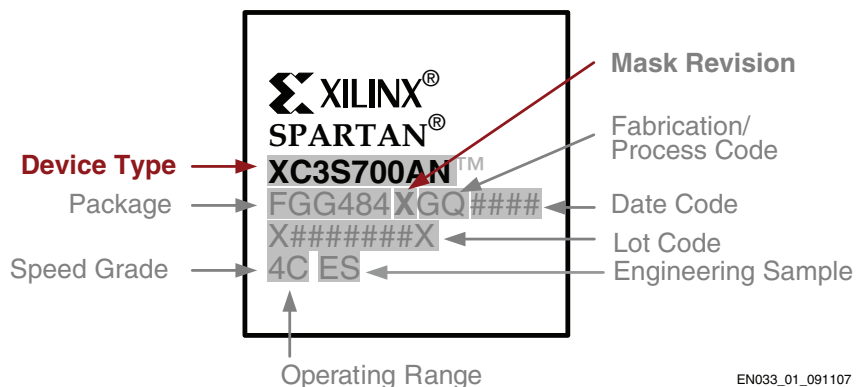
Figure 1: XC3S700AN FPGA Top Marking

These errata apply to the XC3S700AN engineering samples as shown in Table 1. See the top marking in Figure 1.

XC3S700AN engineering samples are marked as shown in Figure 1. The other devices listed in Table 1 are marked similarly.
