## Introduction

Thank you for your interest in the Xilinx Spartan™-3AN family XC3S1400AN FPGA device engineering samples. Although Xilinx has made every effort to ensure the highest possible quality, these devices are subject to the limitations described in this errata notification. These errata do not apply to the XC3S1400AN production FPGAs.

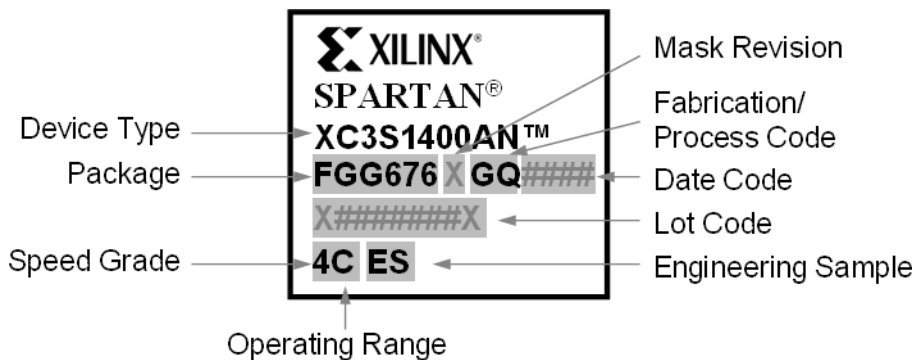
Figure 1: XC3S1400AN FPGA Top Marking

XC3S1400AN engineering samples are marked as shown in [Figure 1](#). The other devices listed in [Table 1](#) are marked similarly.
