IP101/IP101A Application Note

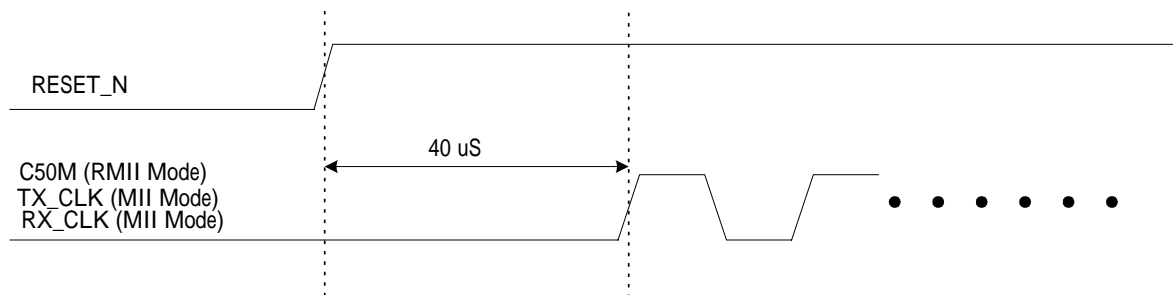
● Relationship between the reset & the clock output

The output delay time of the clock output is around 40us. This time period is measured from the rising edge of reset to the first rising edge of output clock.

The designer should pay attention to this limitation to avoid the improper operation. If the system requires a clock less than 40us delay, the designer can drive the reset of IP101A/IP101 earlier than other devices or use a separate clock source.

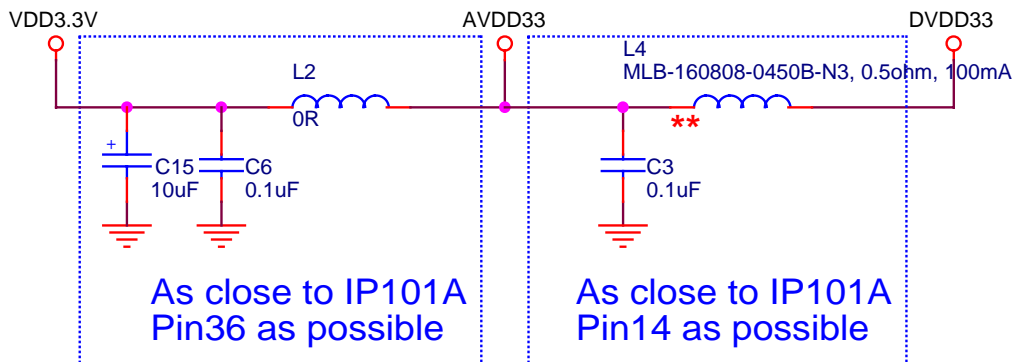
(1) There should be a ferrite bead between DVDD and AVDD to reduce the high frequency noise between these two power sources. Since the ferrite bead is used in the power path, the spec, as shown in the figure, should be different from that used in signal path.

**** Bead should be placed as close to IP101A as possible and in the same side as IP101A.**

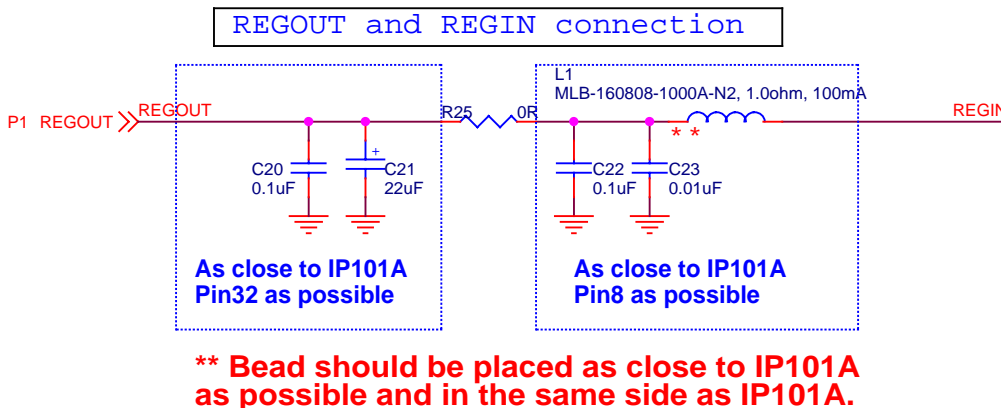
- (3) The ferrite bead and capacitors placed between RegOut and RegIn form a filter array. With these components, the system EMI effect will be greatly suppressed. The decoupling capacitors CB1, CB2, C16 also help reduce the EMI caused by DVDD and should be close to IP101A/IP101.

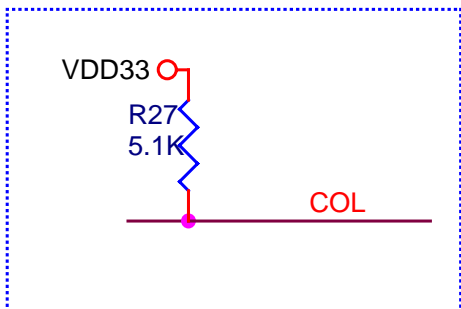
● The MII/RMII mode selection

IP101 : In MII mode ,R27(NC)
In Test mode ,R27(5.1K ohm)

IP101A : In MII mode, R27(NC)
In RMII mode, R27(5.1K ohm)

R27 is reserved for
8201CL/CP LED Mode
Change to compatible
with 8201BL

RTL8201BL : R27(NC)
RTL8201CL/CP : R27(5.1K ohm)
