## Introduction

Thank you for participating in the Spartan®-6 FPGA Engineering Sample Program. As part of this program, we are pleased to provide to you engineering samples of the devices listed in [Table 1](#). Although Xilinx has made every effort to ensure the highest possible quality, these devices are subject to the limitations described in the following errata.

*Table 1: Devices Affected by These Errata*

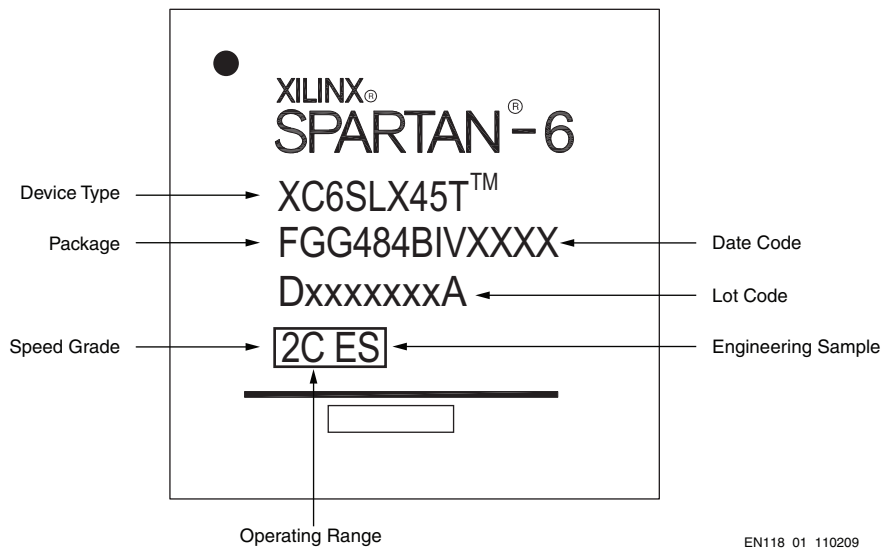
Figure 1: XC6SLX45T-2FGG484CES Marking

The XC6SLX45T is marked as shown in Figure 1. The other devices in Table 1 are marked similarly.
