Introduction

Although Xilinx has made every effort to ensure the highest possible quality, these Virtex[®]-5 FPGA engineering samples (ES) are subject to the limitations described in the following errata.

Table 1: Virtex-5 Devices Affected by These Errata

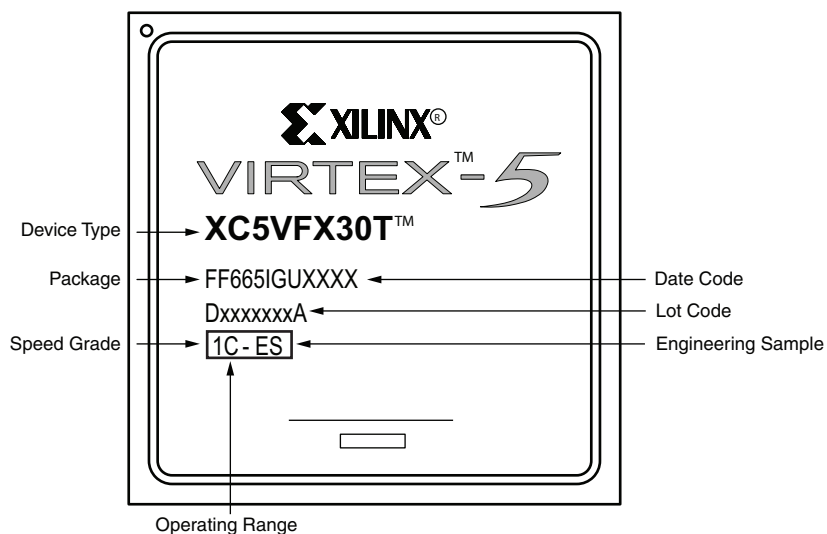
The XC5VFX30T CES is marked as shown in [Figure 1](#). The other devices listed in [Table 1](#) are marked similarly.

Figure 1: Example XC5VFX30T CES Package Marking
