Introduction

Xilinx has made every effort to ensure the highest possible quality. These Virtex®-5 FPGA engineering samples (ES) adhere to the specifications described in the following errata.

Devices

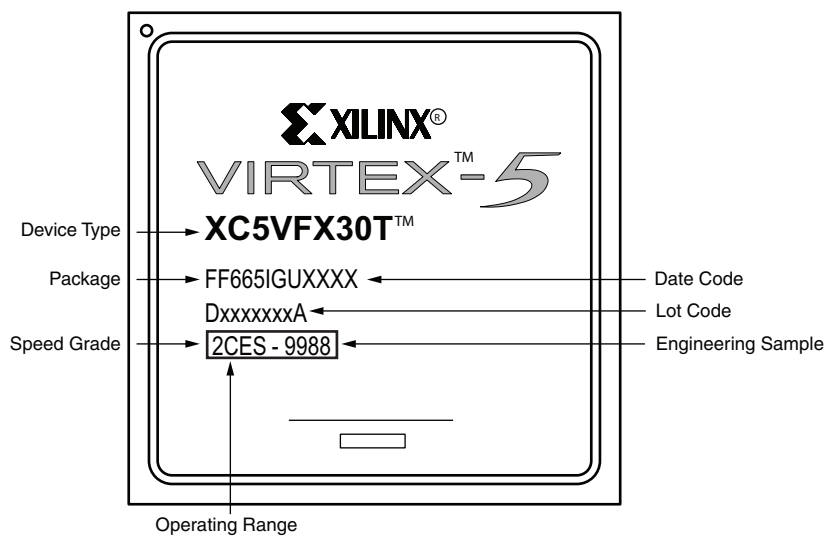
Figure 1: Example XC5VFX30T CES9988 Package Marking

The XC5VFX30T CES9988 is marked as shown in [Figure 1](#). The other devices listed in [Table 1](#) are marked similarly.
