Thank you for designing with the Xilinx Virtex®-6 family of devices. Although Xilinx has made every effort to ensure the highest possible quality, the devices listed in [Table 1](#) are subject to the limitations described in the following errata.

### MMCM

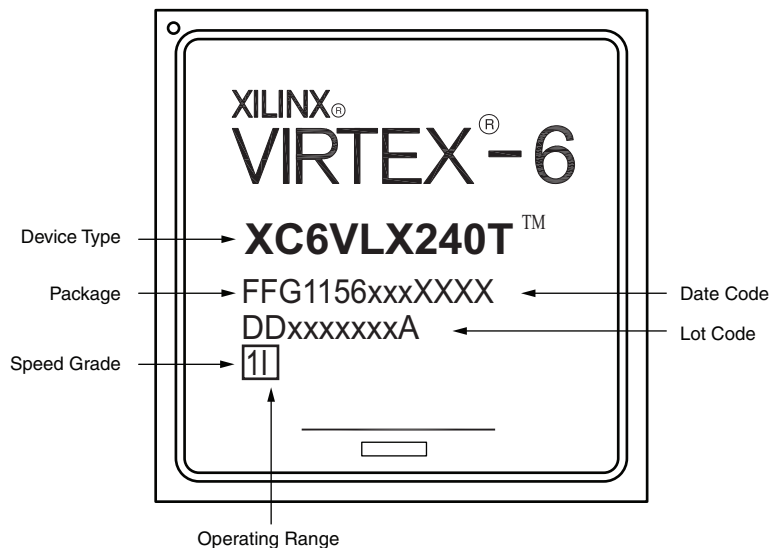
Figure 1: XC6VLX240T-1FFG1156I Marking

The XC6VLX240T is marked as shown in [Figure 1](#). The other devices listed in [Table 1](#) are marked similarly.

EN142\_01\_032610
