## Introduction

Thank you for designing with the Xilinx Virtex®-6 family of devices. Although Xilinx has made every effort to ensure the highest possible quality, the devices listed in [Table 1](#) are subject to the limitations described in the following errata.

*Table 1: Device Affected by These Errata*

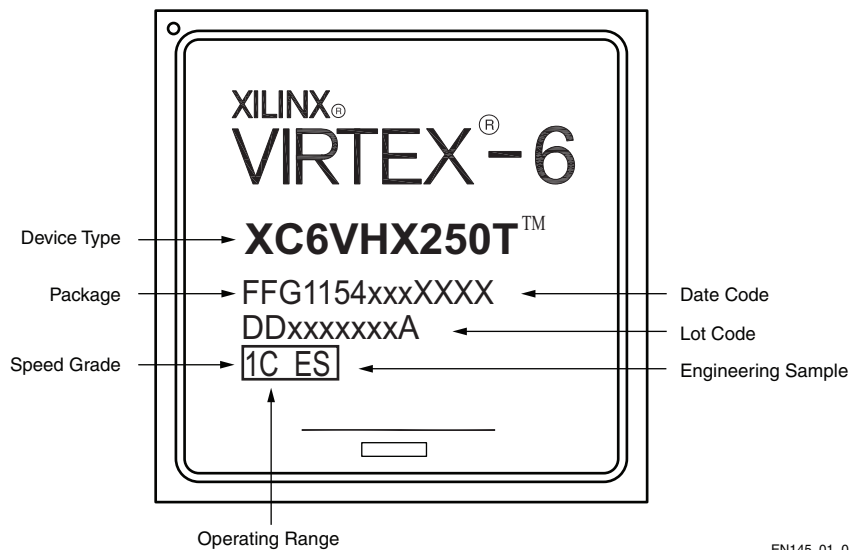
Figure 1: Example Device Top Mark

The XC6VHX250T is marked as shown in [Figure 1](#). The other devices listed in [Table 1](#) are marked similarly.
