## Introduction

Thank you for participating in the Virtex®-6 FPGA Engineering Sample Program. As part of this program, we are pleased to provide to you engineering samples of the devices listed in [Table 1](#). Although Xilinx has made every effort to ensure the highest possible quality, these devices are subject to the limitations described in the following errata.

These errata apply to the devices shown in [Table 1](#).

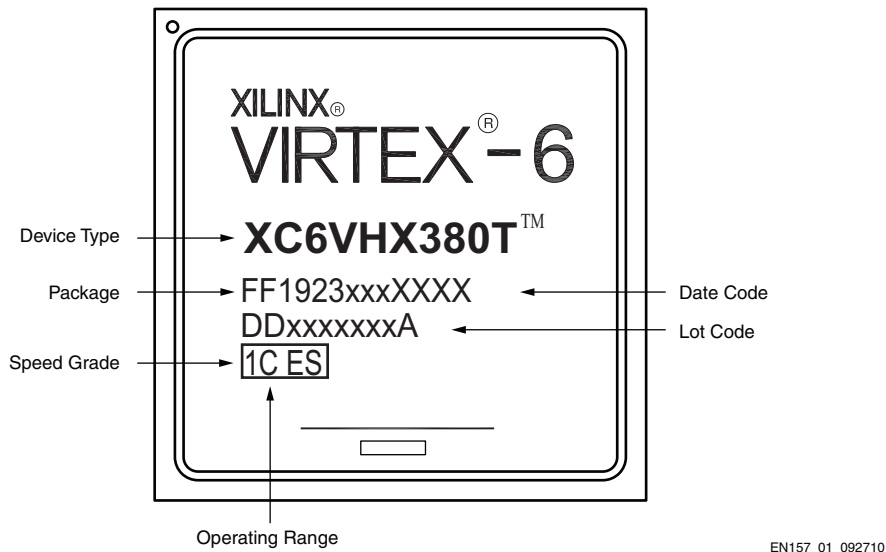
Figure 1: Example Device Top Mark

The XC6VHX380T is marked as shown in [Figure 1](#).
